**Government of India
Bhabha Atomic Research Centre
Multidisciplinary Research Group
Applied Physics Division**

Sub:- *“Repair and Maintenance of existing HV Sphere Fixture Assembly for High Voltage Experiments”.*

Repair and Maintenance of existing HV Sphere Fixture Assembly for high voltage experiments

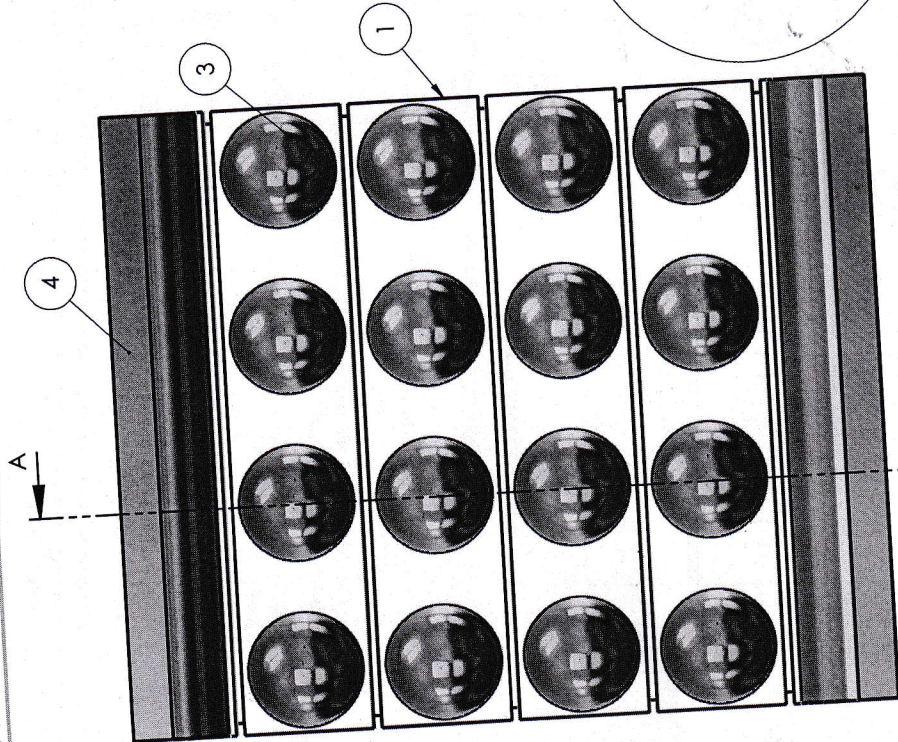
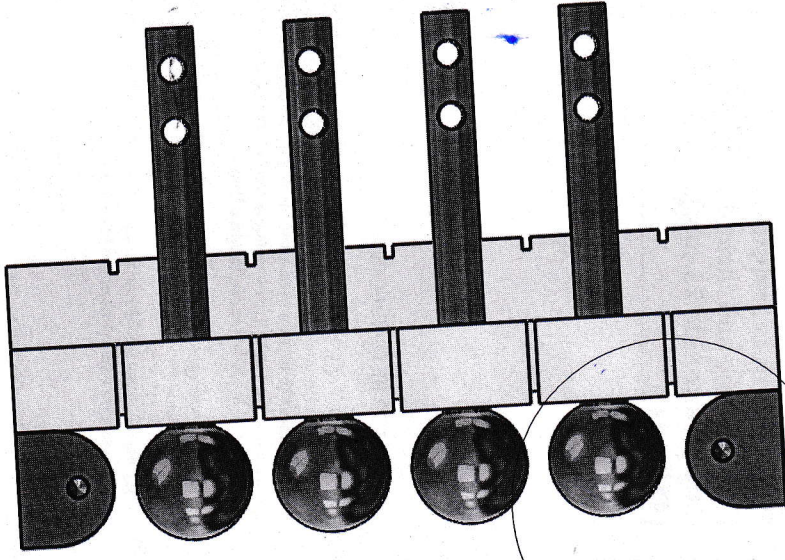
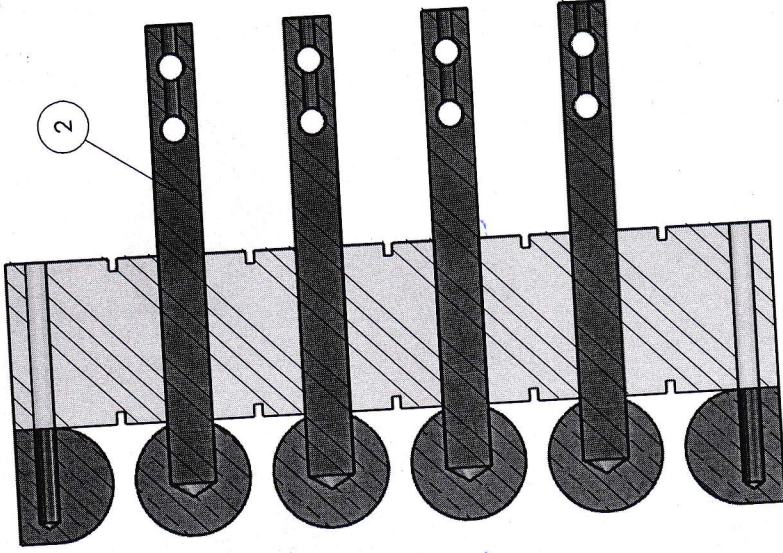
DWG NO. **ASSEMBLY 1**

TOP VIEW

SIDE VIEW

SECTION A-A

The heights of Part 3 and Part 4 should be set so that they are at the same height. Suitable insulated washers may be incorporated to increase the height.

A schematic drawing of the assembly with all its constituent parts is provided as a reference for the repair and maintenance of the given job. A detailed account of the repair and maintenance schedule, which is in the scope of the fabricator, is summed up in the following points:

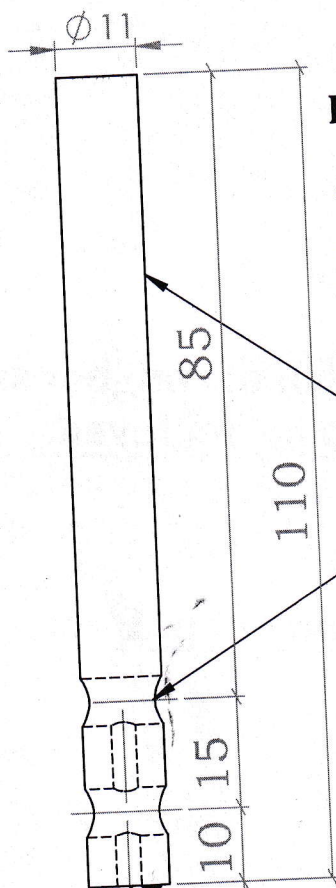
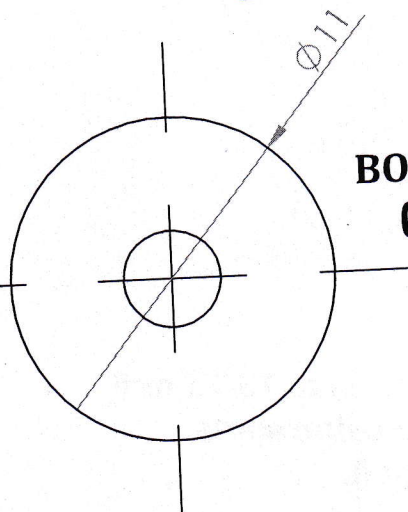
MATERIAL:	SS 304	DWG NO.	PART 2
-----------	--------	---------	--------

FRONT VIEW

This is basically a modified M12 SS304 stud. The entire body of this stud [except the 36 mm from Plane A] must be threaded to mate with corresponding $\phi 10.2$ holes in Part 1.1.

$\phi 6.5$ mm Thru. holes, 2 Nos.

M4 tapping, 25 mm deep, 1 no. for insertion of headless M4 SS304 Allenhead bolts

BOTTOM VIEW (PLANE-A)

- 1) Change in the diameter of the SS304 studs, similar to an M12 stud.
- 2) Removal of threads from exposed surfaces
- 3) Replacement of the Delrin nuts associated with the PART 2.
- 4) Diamond polishing of component.

- 4. PART 2: a) Change in the diameter of the SS304 studs, similar to an M12 stud, b) Removal of threads from exposed surfaces, c) Replacement of the Delrin nuts associated with the PART 2.*

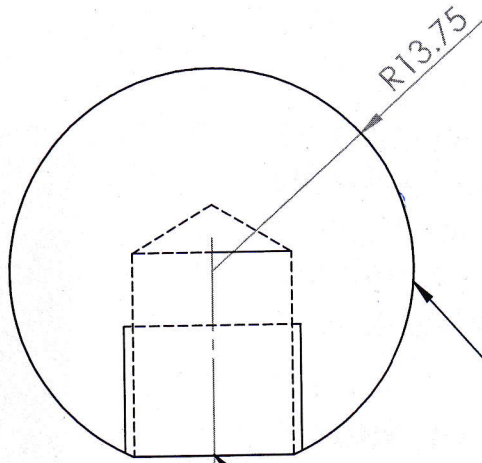
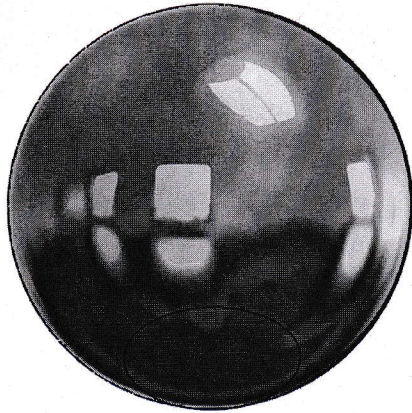
PART 3

Surface finish of roughness grade N3 to be achieved.

M12 Tapping, 15 mm deep, 1 no.

- 1) Change in the PART radius from dia. 14.50 mm to 13.75 mm
- 2) Diamond polishing of the Part to remove erosion spots.
- 3) Surface roughness of grade N3 to be obtained.

- 1) Roughness test certificate conducted by a NABL accredited laboratory to be provided after the repair and maintenance job on PART 3.

- 6. Tests to be conducted for PART 3: Roughness test certificate conducted by a NABL accredited laboratory to be provided after the repair and maintenance job on PART 3.*

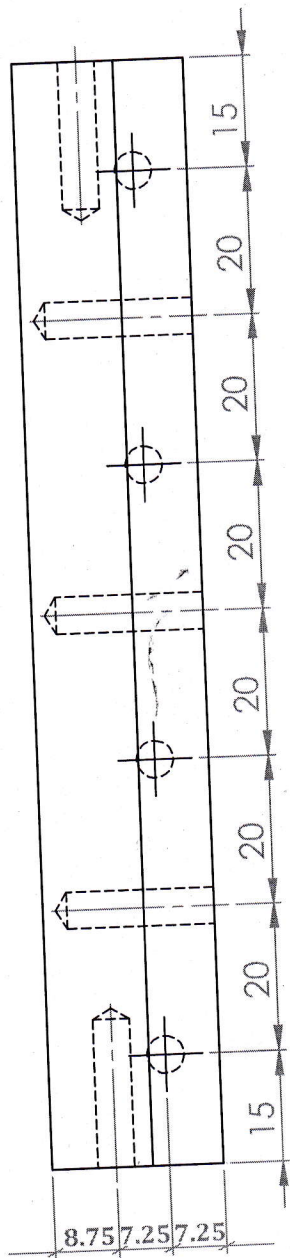
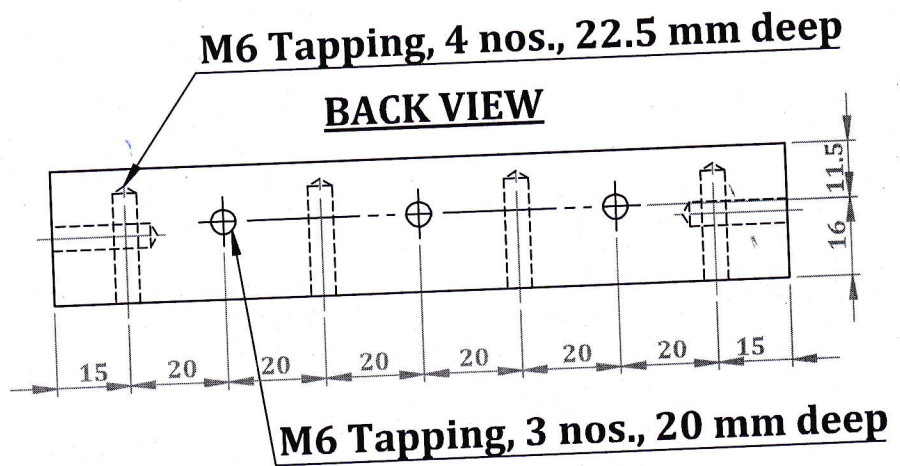
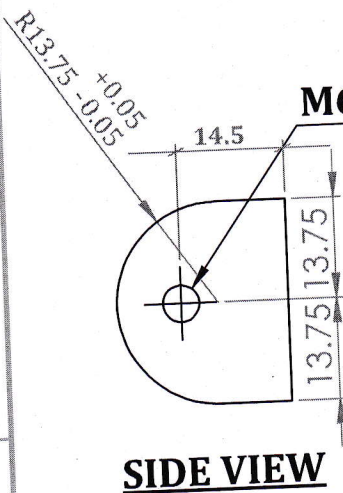
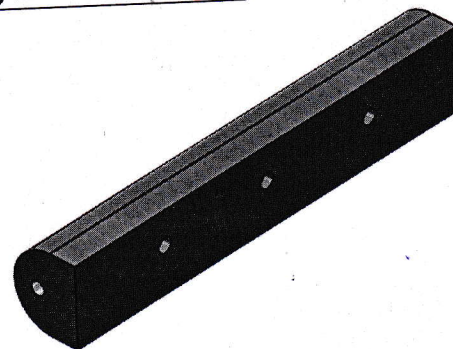
DWG NO. **PART 4**

- 1) Change in the PART radius from dia. 14.50 mm to 13.75 mm
- 2) Diamond polishing of the Part to remove erosion spots.
- 3) Surface roughness of grade N3 to be obtained.
- 4) Change in placement of M6 Threads with replacement of SS304 Heli-coils.

- 1) Roughness test certificate conducted by a NABL accredited laboratory to be provided after the repair and maintenance job on PART 4.

- 7. PART 4: a) Change in the PART radius from dia. 14.50 mm to 13.75 mm, b) Diamond polishing of the Part to remove erosion spots, c) Surface roughness of grade N3 to be obtained and d) Change in placement of M6 Threads with replacement of SS304 Heli-coils.*

- 8. Tests to be conducted for PART 4: Roughness test certificate conducted by a NABL accredited laboratory to be provided after the repair and maintenance job on PART 4.*
