CIVIL STRUCTURES FOR BACK-END FUEL CYCLE FACILITIES **Design, Construction and Ageing Management**

Somya Khare, Ajay Shirole, R. B. Sastry, R. R. Rakesh and P. D. Maniyar

The authors are from Nuclear Recycle Group Projects, Bhabha Atomic Research Centre, Mumbai.

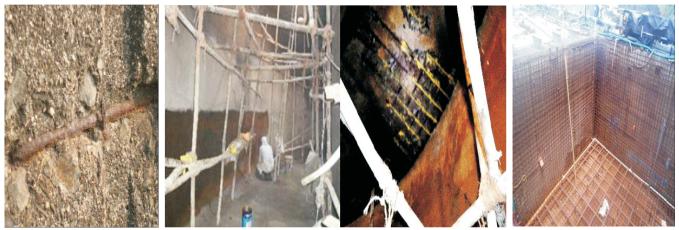
Fig.6: (a) 135m high stack.

(b) Underground water tank.

(c) LLW Tanks.

i. 135 m High Stack: The 135 m stack of FRD plant was nearly 50 years old at the time of its restoration. The structure was showing signs of distress due to ageing as shown in Fig.6(a). To carry out the condition assessment and repair of 135m high stack, special scaffolding erection and its dismantling arrangements were made. The scaffolding design was carried out and vetted by the experts in the field. Structural repair was carried out using special repair mortar, replenishing exposed/corroded reinforcements, injecting low viscous grout for repairing cracks in concrete and finally an UV resistant anticarbonation coating was applied on the complete outer stack surface. Personnel qualified with rigorous health checks ascertaining their capability for working at higher elevations were only deployed for carrying out this work. The restoration work was accomplished successfully without any safety related incidence.

ii. Underground Water Tank: This is a circular tank with annular partition having a tank inside tank ($12m \emptyset$ internal tank and $18m \emptyset$ outer tank) having two openings of $600mm \emptyset$ in each tank. Spalling concrete and exposed reinforcement were observed during its condition assessment as shown in Fig.6(b). Outer tank repair in restricted annular space of 3m width with humid environment inside resulted in tough working conditions. Continuous seepage of groundwater from the walls and floor of the tank necessitated grouting the cracks in the wall with polyurethane for ensuring leak tightness of the

structure during repair work. Micro-concrete was used for filling the pits in the concrete slab. Crystalline coating was applied on the inner surface of the tank to increase its leak tightness. Finishing coat of food grade epoxy coating was provided on the inner surfaces as this tank stores potable water. The tank was repaired successfully and is functional now.

iii. LLW Tanks: MS lined RCC underground LLW treatment tanks at ETP are more than 60 years old. Condition assessment of 02 Nos. of LLW tanks revealed that these structures are in distressed condition. These structures have been restored by removing MS lining, structural repairs, grouting and increasing RCC wall & raft thickness by providing layer of RCC as shown in Fig.6c. New and old RCC members were connected by using shear connectors. SS lining has been provided on internal surface of the tanks. With this restoration, the tank life has been enhanced for uninterrupted operations of the LLW treatment.
